PRITCHARDS POND DAM, Waterbury, CT  
CT 00033

NAUGATUCK RIVER BASIN  
WATERBURY, CONNECTICUT

PHASE I INSPECTION REPORT  
NATIONAL DAM INSPECTION REPORT

Name of Dam : Pritchards Pond Dam  
Identification Number: CT 00033  
Town : Waterbury  
County and State : New Haven County, Connecticut  
Stream : Hopeville Pond Brook  
Owner : Risdon Manufacturing Company, 2100 South Main Street,  
Waterbury, Connecticut  
Date of Inspection : December 3, 1980

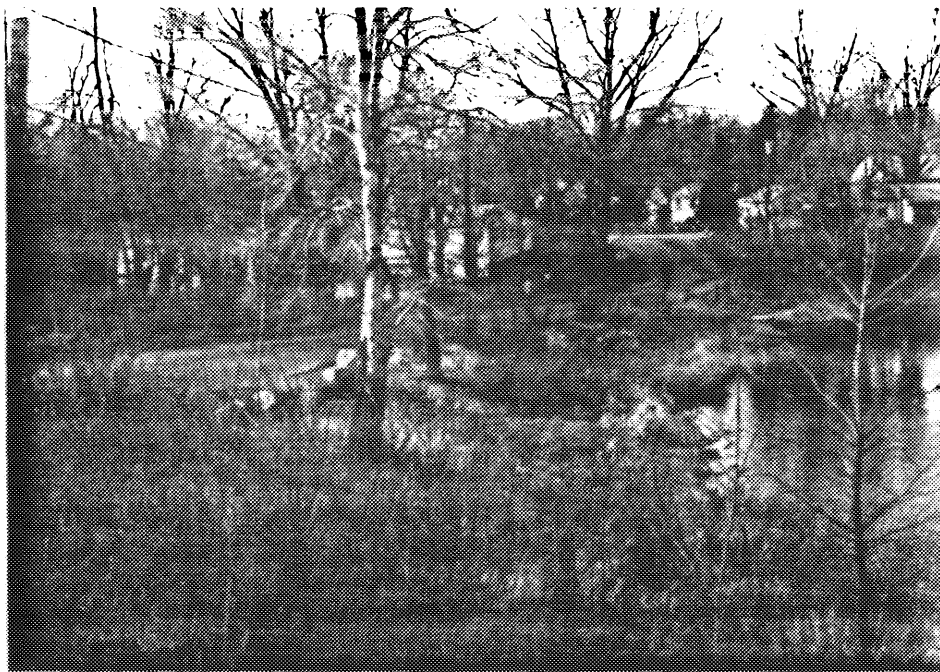
1. Left abutment, looking along crest.

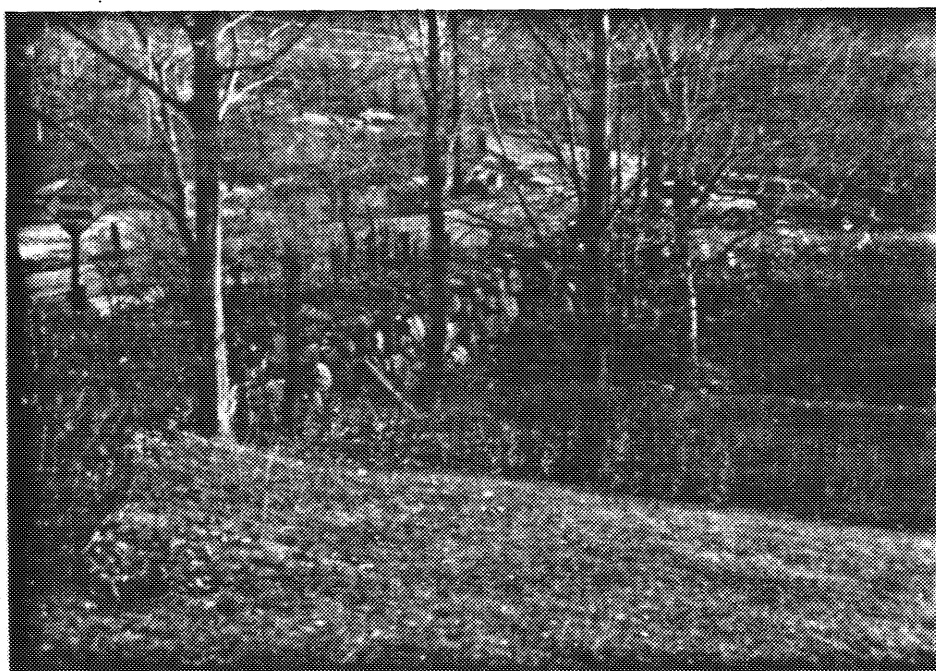
2. Right abutment, looking along downstream face.

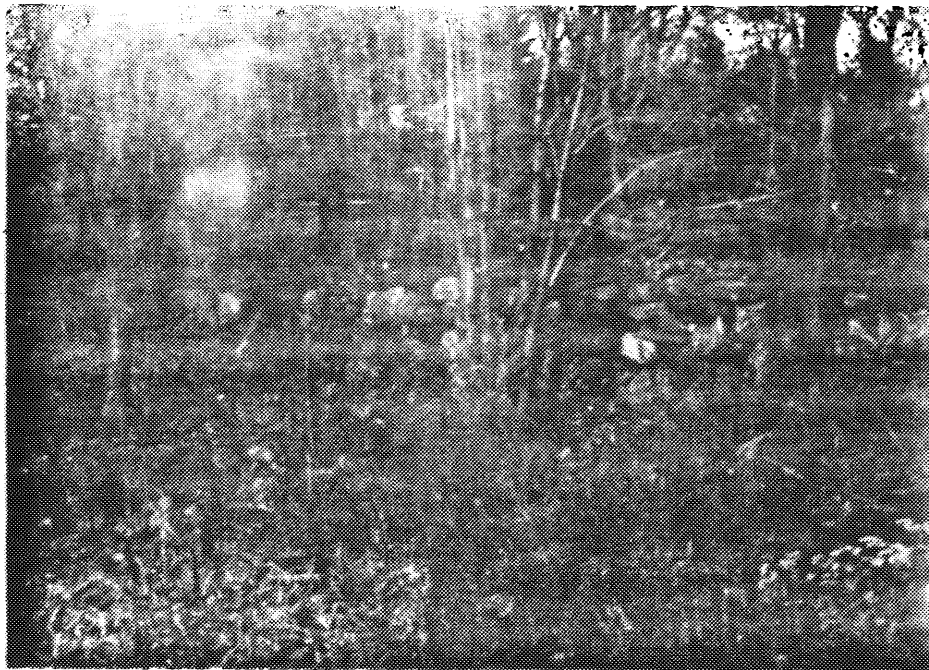
3. Downstream face of dam, looking towards right side of spillway channel. Note 14" diameter tree in right side of photo and clump of 5 trees in center of photo.

The dam appears in good shape but requires some work. Specifically, this would include developing a functioning outlet works, spillway maintenance and removal of trees on or close to the dam.

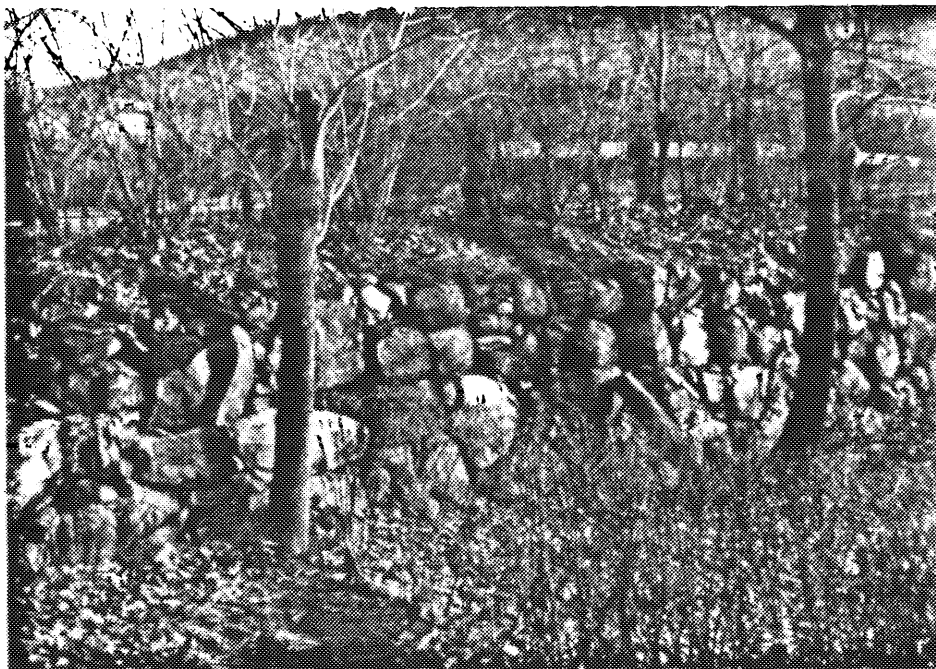
4. Sta 2+10 looking at downstream face of dam, blue flagging at Sta 2+00, tree stump on left, 8" diameter, tree on right of photo 11" diameter.

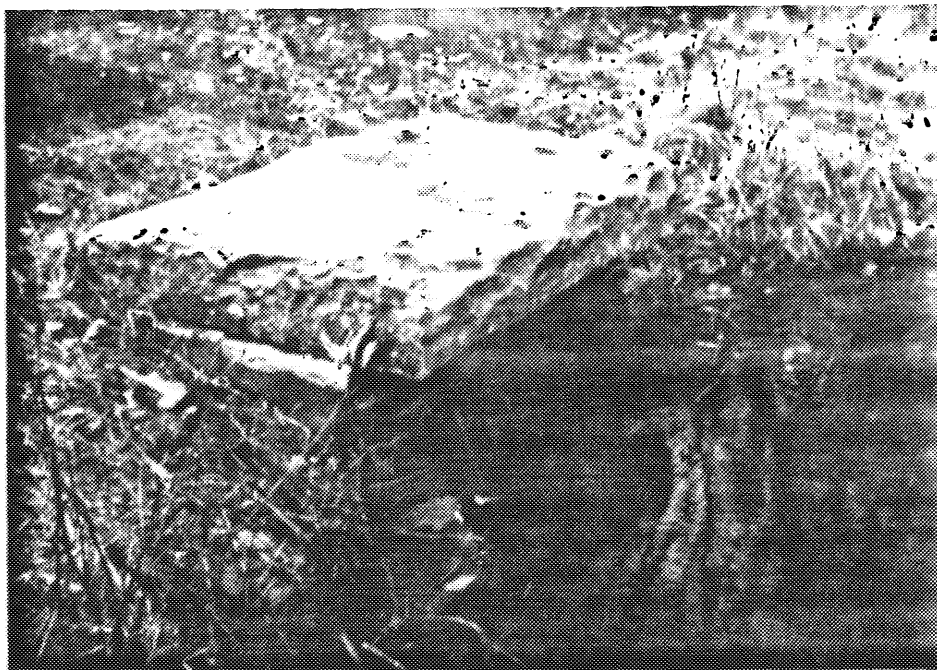
5. Spillway intake structure with trash rack.

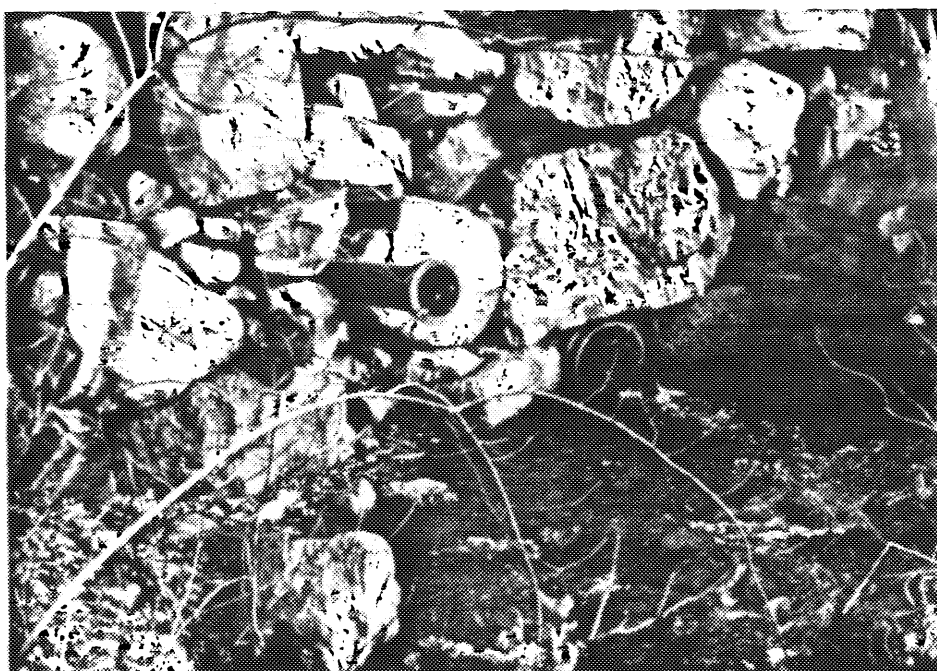
6. Spillway and outlet discharge pipes.

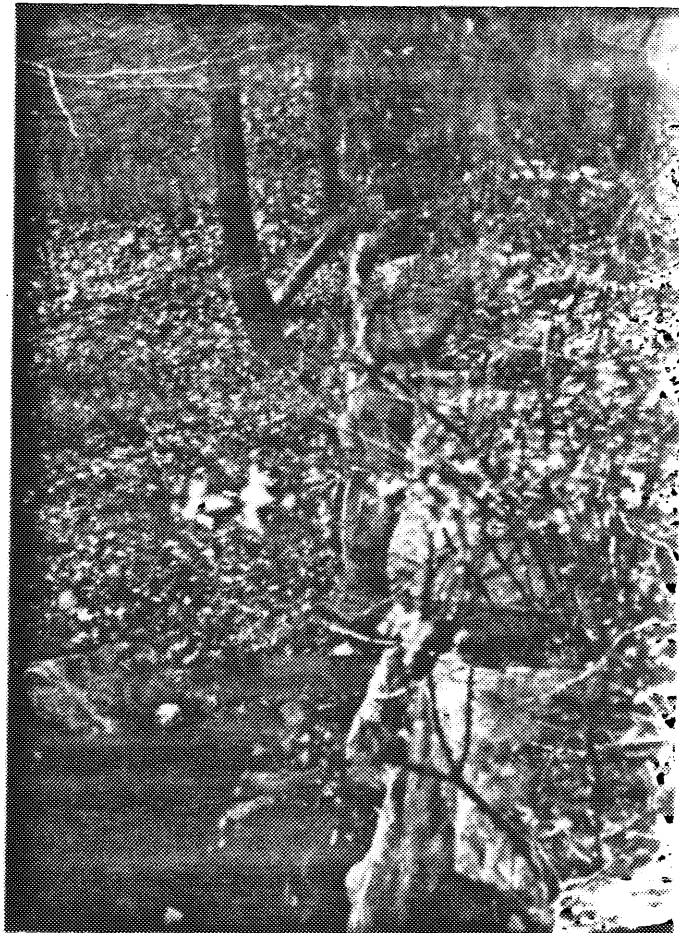
8. Downstream channel.

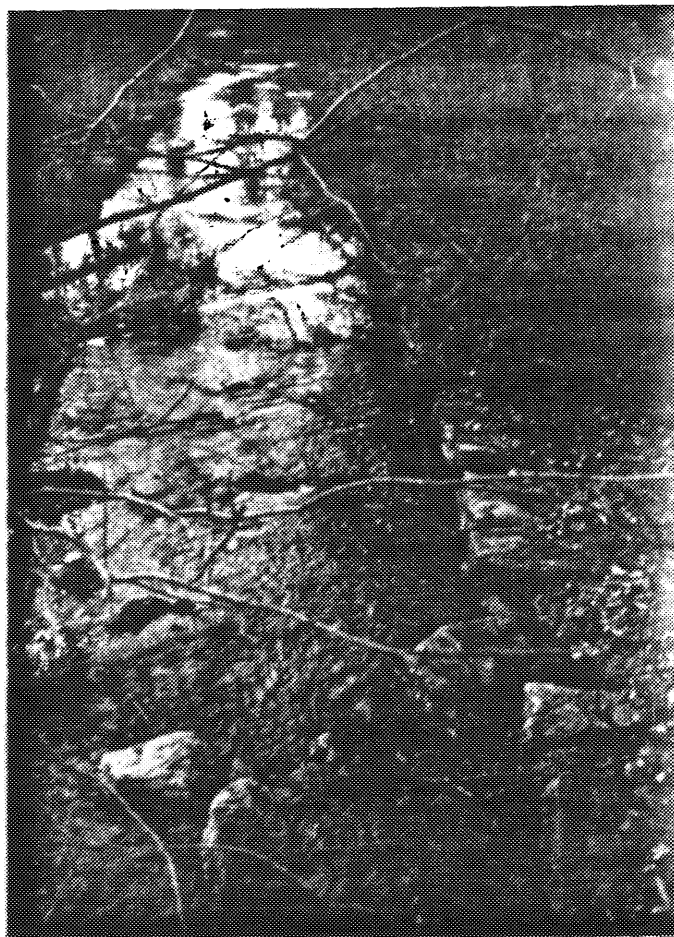
7. Downstream face of dam looking towards right downstream bank.
